Software Release Notes

mPower® Edge Intelligence Software Includes mPower 6.3.0

MultiTech Conduit® Gateway
MultiTech Conduit® IP67 Base Station
MultiTech Conduit® IP67 200 Series Base Station
MultiTech Conduit® AP Access Point

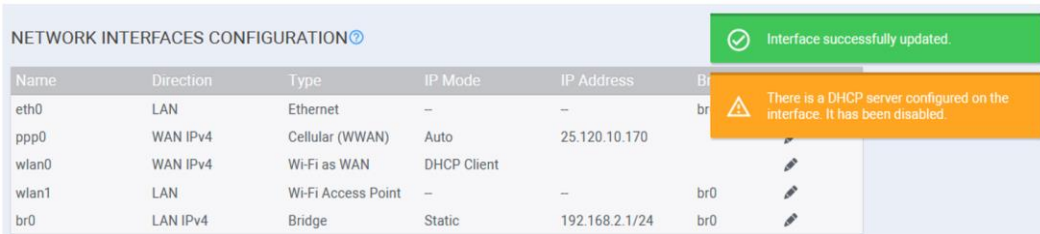
DHCP Server Interface <ul style="list-style-type: none"> In previous versions of mPower, when a network interface is excluded from br0 and had its own DHCP server configured, the DHCP server remains enabled when the interface is added back to the br0 In mPower 6.0.1, a yellow warning message is displayed on the NETWORK INTERFACES CONFIGURATION window
