## Software Release Notes

### mPower® Edge Intelligence Software Includes mPower 6.3.6

MultiTech Conduit® Gateway  
MultiTech Conduit® IP67 Base Station  
MultiTech Conduit® IP67 200 Series Base Station  
MultiTech Conduit® AP Access Point

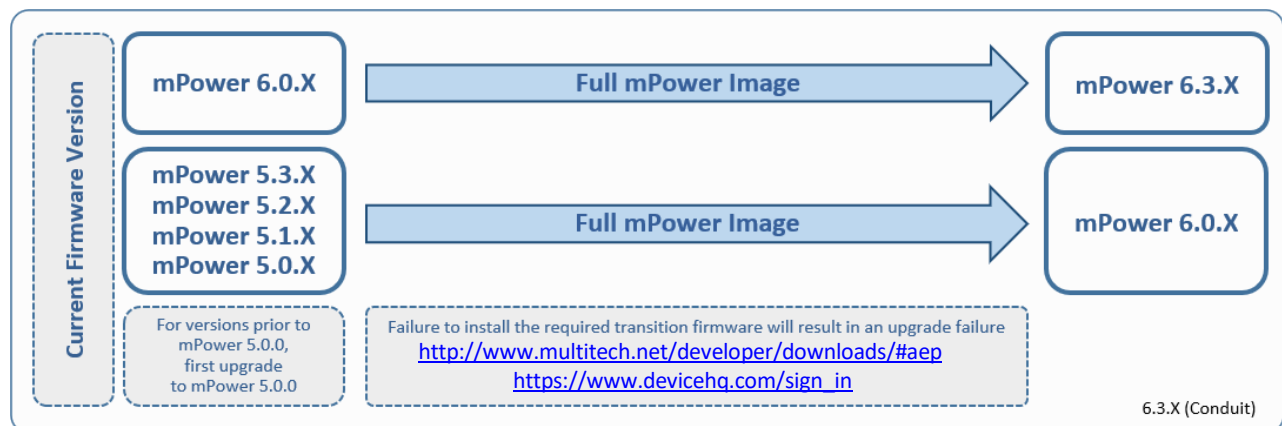
To install mPower 6.3.6, the Conduit gateway must be upgraded to mPower 6.0.0 or higher. Customers that are running earlier versions of mPower should use the following upgrade process.

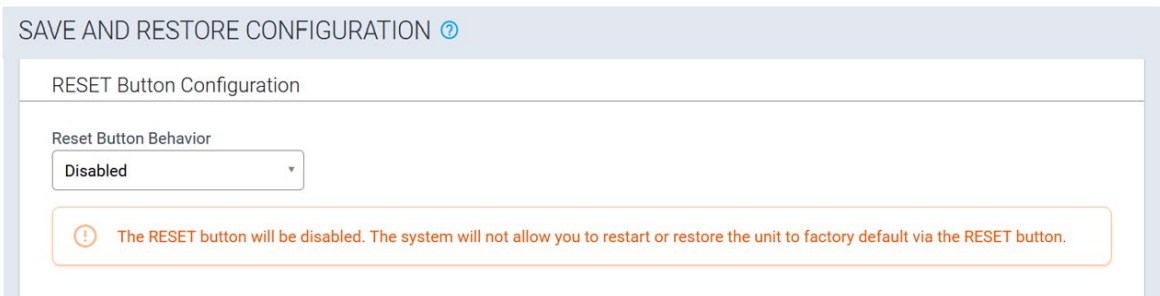
Hardware Support	
<p><b>RESET Button Configuration</b></p> <p>In the User Interface, the Save and Restore Configuration page has been updated to include a new RESET Button Configuration. The following option is available:</p> <ul style="list-style-type: none"> <li><b>Disabled</b> – The system will not allow you to restart or restore the unit to factory default via the RESET button</li> </ul>

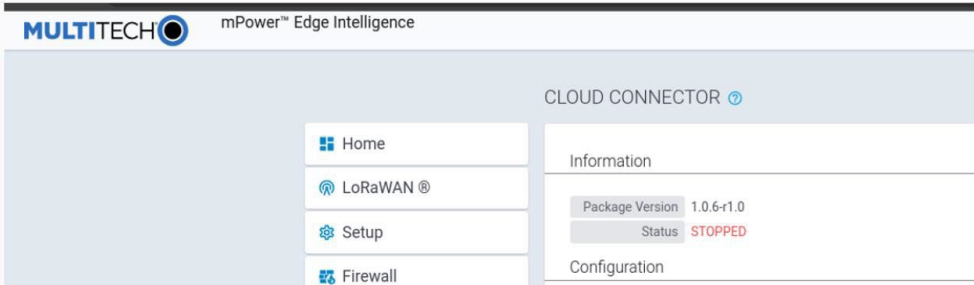
<b>Software &amp; Services – LoRaWAN Features</b>	
<b>Default Application – Name Change to Cloud Connector</b> <ul style="list-style-type: none"> <li>In mPower 6.3.1, the Default Application is renamed Cloud Connector</li> <li>Cloud Connector allows last mile bi-directional communication from the gateway to a cloud application (Generic MQTT, AWS &amp; Azure) without needing to deploy custom code on each gateway; this allows LoRaWAN uplinks and downlinks to be easily consumed and produced by a cloud application. New features include the ability to trigger request and receive responses via MQTT for LoRa queries, logging, and device API's.</li> </ul> <p>Please see the following link for additional info:  <a href="https://multitechsystems.github.io/lorawan-app-connect-mqtt">https://multitechsystems.github.io/lorawan-app-connect-mqtt</a></p>

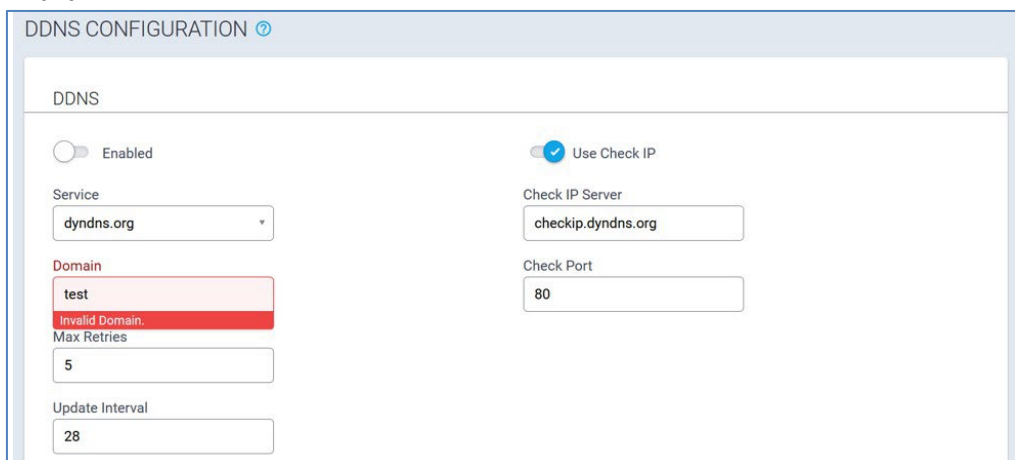
### DDNS Configuration Page

- In mPower 6.3.0, DDNS configuration changes are not submitted when Domain value is invalid.

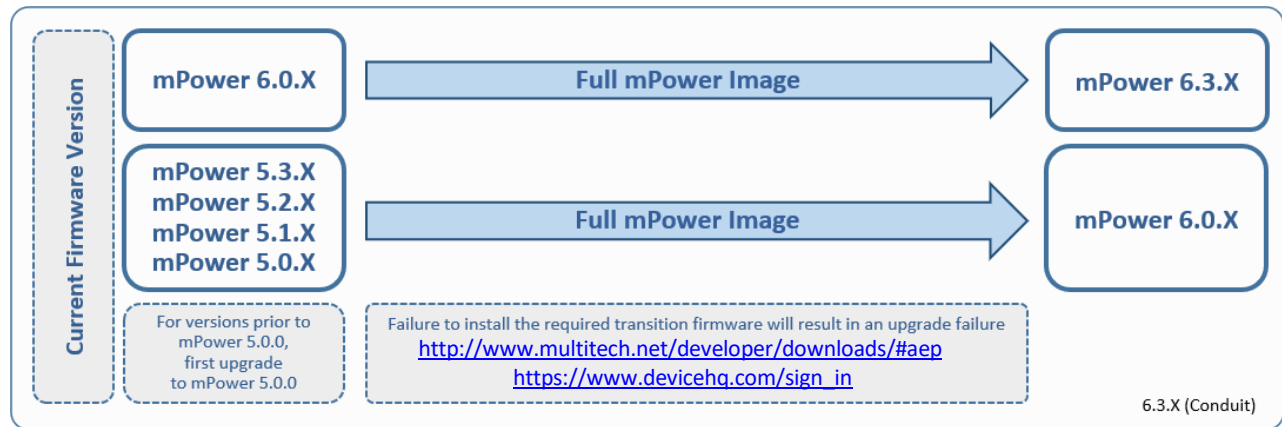
To install mPower 6.3.1, the Conduit gateway must be upgraded to mPower 6.0.0 or higher. Customers that are running earlier versions of mPower should use the following upgrade process.

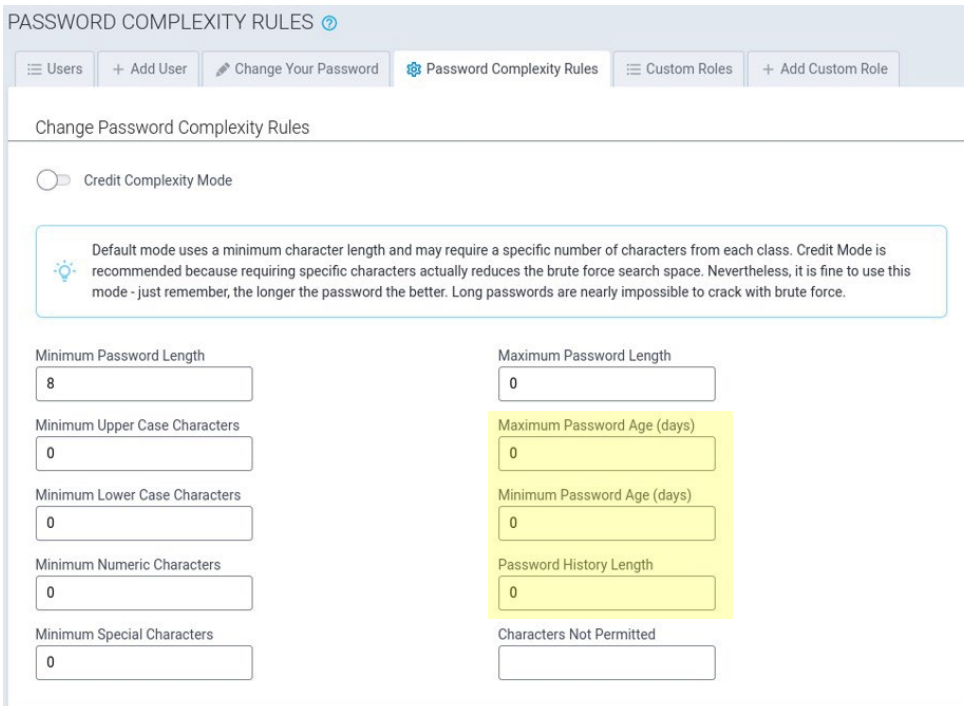
PASSWORD COMPLEXITY RULES ⓘ

#### Password Complexity – History Length

The number of previous passwords (including the current password) that will be remembered for a user account before a specific password can be reused

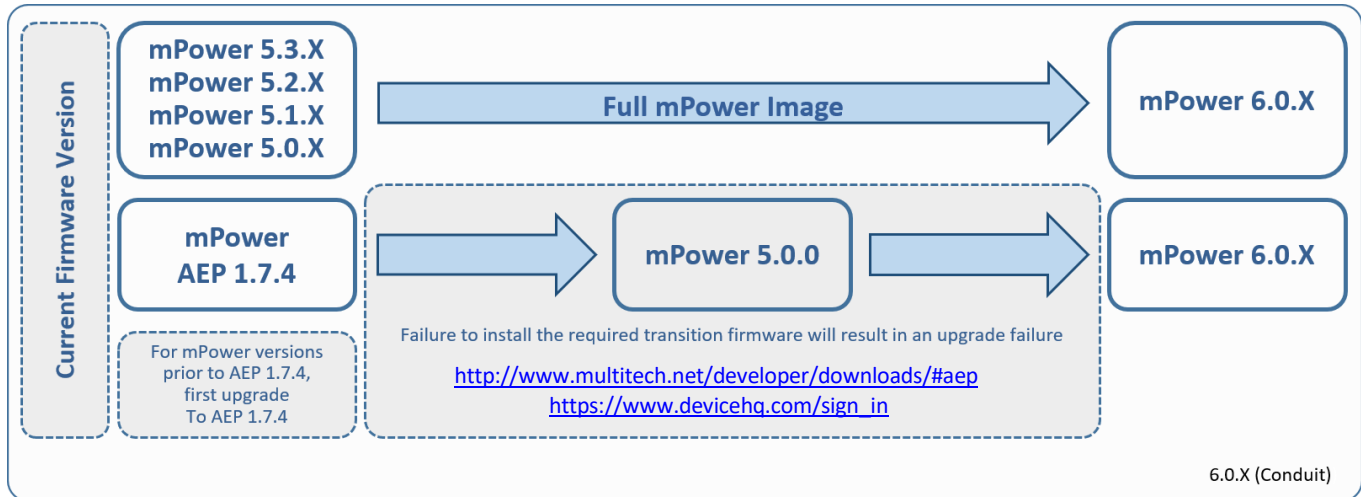
To install mPower 6.0.4, the Conduit gateway must be upgraded to mPower 5.0.0 or higher. Customers that are running earlier versions of mPower should use the following upgrade process.

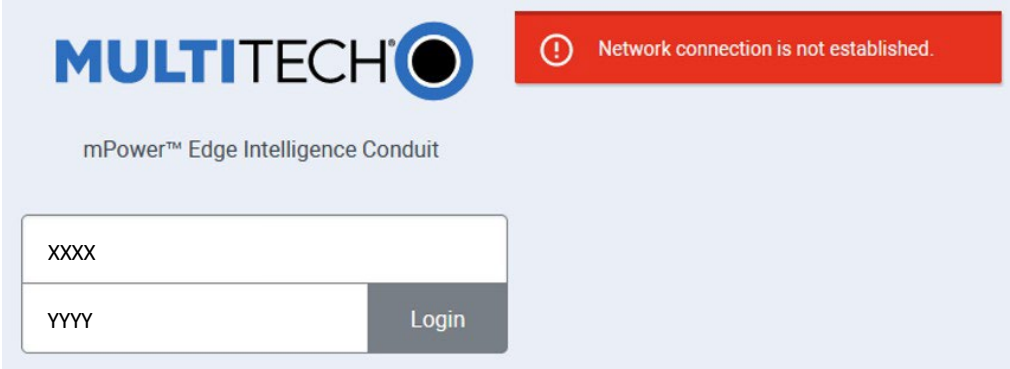
<p><b>Web Interface, Login Page</b></p> <ul style="list-style-type: none"> <li>During the login process, if connection to the device is lost, a new message is displayed <i>Network connection is not established.</i></li> </ul>
